1st International Conference on Structural Integrity

Structural Analysis of Ageing Pilatus P-3 Engine Mount

Michel Guillaume^{a,*}, Elias Schläpfer^a, Marcel Schmid^a^a ZHAW Zurich University of Applied Sciences, Technikumstrasse 9, CH-8401 Winterthur, Switzerland

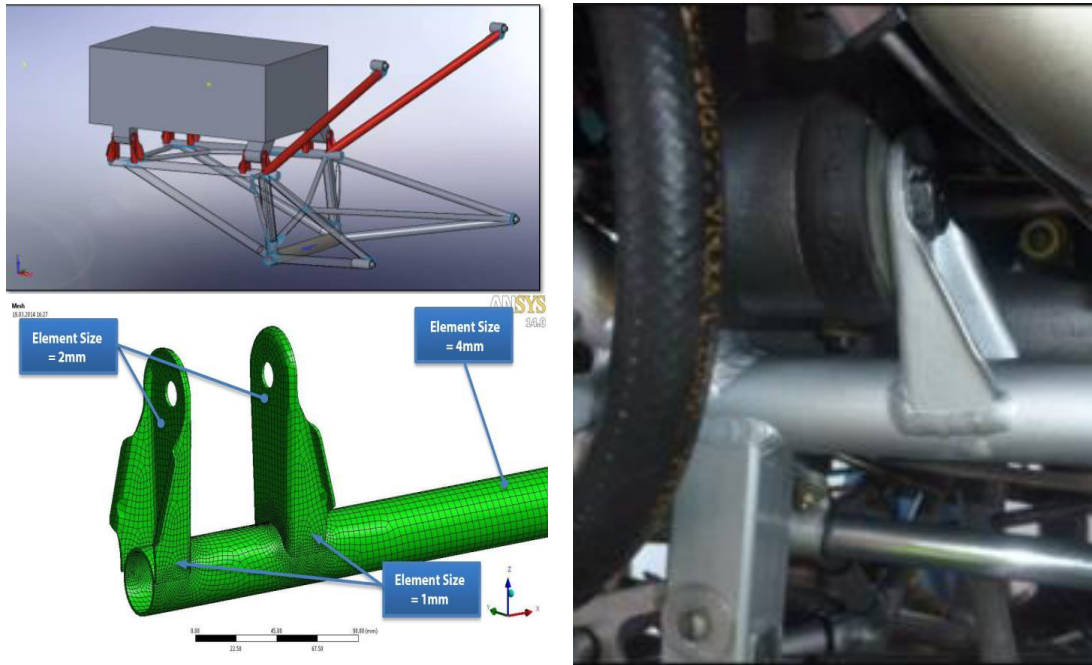
Fig. 5. Engine mount structure with FE model, and detailed picture of aft engine mount tab

The results of the FE model showed large deformations of 4.0 to 4.8mm at the left hand forward engine mount tab. The static analysis was based on the FKM requirements, see [2]. Based on the static strength analysis the ultimate load cases of steady state 6G maneuver and horizontal spin maneuver exceeded the tensile strength of steel AISI / SAE 4130. Local plasticity was not modeled in detail which would give more accurate results.

With the corresponding FE results for the N_z values, the spectrum could be converted to stresses at the critical locations based on the principal stresses of the FE sub model data. The most critical locations are the aft engine mount tab, and upper connection bolt to the forward fuselage, see Fig. 5. For fatigue investigations the flying steady maneuver loads are contributing to the fatigue damage.

We recommend the inspection of the 5 most critical locations in the area of the engine mount tab (engine connections) and connection bolt (upper and lower bolt connection to fuselage frame) every 100 FH or once a year. This can be included in the maintenance plan for the regular 100 FH maintenance inspection program.

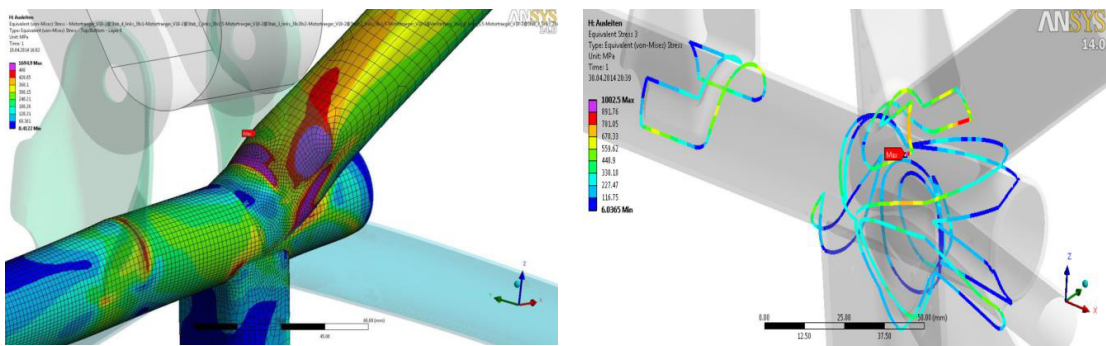
Fig. 6. Critical stresses FE analysis (left), CAB detailed analysis for critical structure (right)

Therefore at the critical connections the special hot spot procedure (CAB process) [3] was used to perform the static analysis on the weld, see Fig. 6. The equivalent von-Mises stresses at some locations were in the range of 87ksi. Also the upper bolt connection to the fuselage had very high stress levels as well.

A lot of effort was spent to determine the impact on local yielding at the high stress areas in the detailed analysis. The so called CAB method was very helpful. The safety factors at critical locations showed values above 1 for all load cases up to $N_z=6G$ (limit load) with exception of the horizontal spin load condition. This load case will no more be practiced in the civil operation based on pilot interview. This restriction has to be included in the flight manual for civil operators.

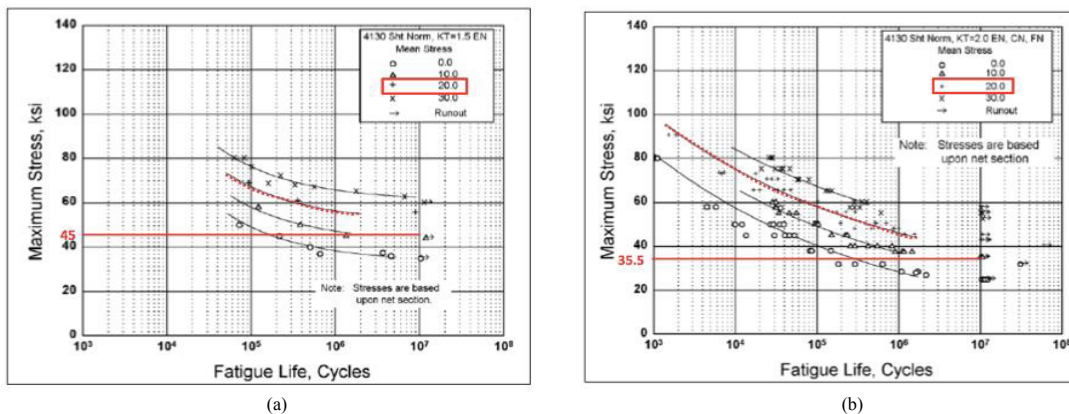
In the first approach MIL-HDK-5J data [4] for steel AISI / SAE 4130 at $kt=1.5$ and $kt=2.0$ was used for max/min stress level (severe cycle) to see if the fatigue life is in the area of the durability life. This kt values are considered because the engine mount tab has a stress concentration factor of kt of 1.25 and the connection bolt a kt of 2.0. The max stress for the engine mount tab was 35.5 ksi respectively 45 ksi for the connection bolt at mean stress of 20ksi. Both values are below the red dotted curve at 107 cycles, see Fig. 7a and b. This confirms that the two locations have a durability life.

At the end, we have done a train life calculation with Miner damage accumulation using the design test rainflow matrix and the military usage rainflow matrix. For most critical location at the engine mount tab we got a Miner damage sum of 1.2 for the P-3 test spectrum and 0.4 for the military usage spectrum. This was based on the 5'000 FH test life. Based on the Miner damage sum of 1.2 the engine mount could have some cracks at the end of the P-3 fatigue test. The Miner damage sum of 0.4 for military usage would not show cracks at 5'000 FH.

Fig. 7. (a) Stress life curves for $kt=1.5$; (b) stress life curve for $kt=2.0$.
